DEPARTMENT OF TRANSPORTATION

Quality Assurance and Source Inspection

Contract #: 04-0120F4Cty: SF/ALA Rte: 80 PM: 13.2/13.9File #: 69.28**WELDING INSPECTION REPORT****Resident Engineer:**Siegenthaler, Peter**Address:** 333 Burma Road**City:** Oakland, CA 94607**Report No:** WIR-019136**Date Inspected:** 05-Jan-2011**Project Name:** SAS Superstructure**OSM Arrival Time:** 700**Prime Contractor:** American Bridge/Fluor Enterprises, a JV**OSM Departure Time:** 1900**Contractor:** Zhenhua Port Machinery Company, Ltd (ZPMC), Changxing Island **Location:** Shanghai, China**CWI Name:** Li Yang**CWI Present:** Yes No**Inspected CWI report:** Yes No N/A**Rod Oven in Use:** Yes No N/A**Electrode to specification:** Yes No N/A**Weld Procedures Followed:** Yes No N/A**Qualified Welders:** Yes No N/A**Verified Joint Fit-up:** Yes No N/A**Approved Drawings:** Yes No N/A**Approved WPS:** Yes No N/A**Delayed / Cancelled:** Yes No N/A**Bridge No:** 34-0006**Component:** OBG Segment**Summary of Items Observed:**

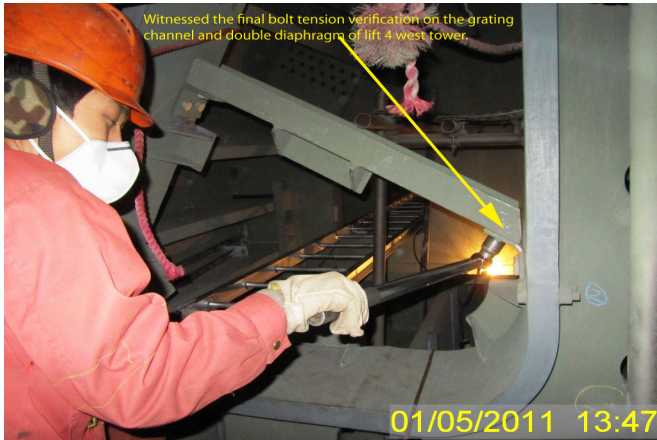
This QA Inspector witnessed the final bolt tension verification on the grating channel and double diaphragm of lift 4 west tower. The torque wrench S/N was 1003153. The QA Inspector witnessed 10% of the bolts on a random basis and found the tensioning of the bolts appeared to be in general compliance with the contract specifications. The bolt size designations were as follows:
